Qualideck®

CRACK DETAIL

DWG NO.:
CD-002

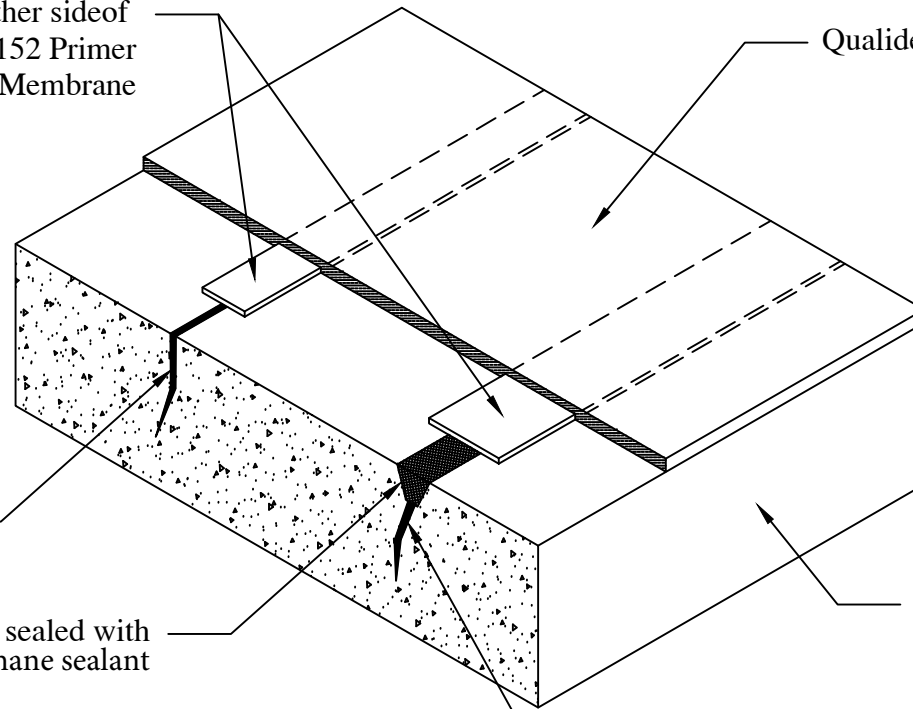
Detail Coat on 3" minimum either side of the joint with Qualipur 152 Primer followed by Qualipur 252 Membrane

Qualideck Coating System

Crack less than $\frac{1}{16}$ " width

Routed and sealed with polyurethane sealant

Structural slab

Crack greater than $\frac{1}{16}$ " width
